# MILLE LACS RESERVATION TRIP REPORT

## Assessment of Mold and Moisture Conditions

### Final Report

Date:  
May 27-30, 2003

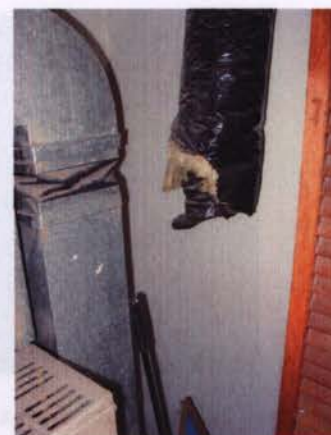
Forced air furnaces (propane) are used for space heating. Furnaces are generally 80% efficient. Replacement furnaces and furnaces in the new homes are 90% efficient and are direct vent sealed combustion (Figure 2). Water heaters in existing homes are either natural draft propane or electric. Electric water heaters are being installed in the new homes. Many of the existing

**Figure 2 – Combustion air intake – typical.**

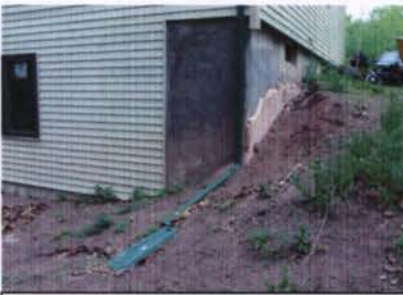
**Figure 5 – Rainwater is directed to rear of home.**

The lack of properly functioning gutter systems compounds the site drainage problem and creates a potential mold problem as all of the rainwater and snow melt collects around the perimeter of the home (Figures 5, 6 & 7).

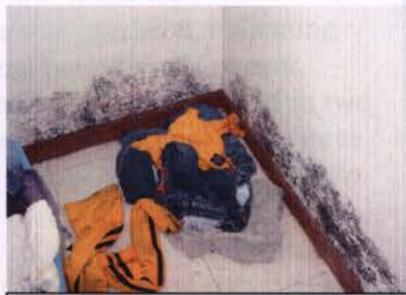
**Figure 6 – Mold on exterior in half basement**

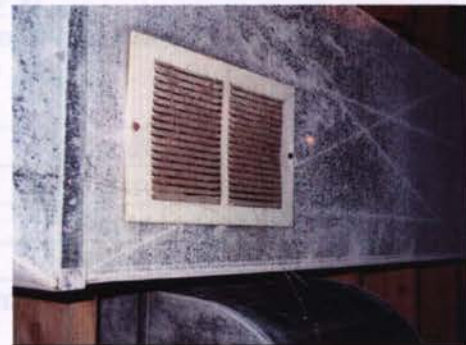
With regard to indoor air quality issues, the return air ducts found in eight of the crawl spaces were a great concern. Two return air grilles were found on these systems (Figure 9). Return air systems pull air into the distribution system. Thus, dirt, moisture and other contaminants are being pulled-in from the crawl space and distributed throughout the home.

Figure 9 – Open return air grille in crawl space.

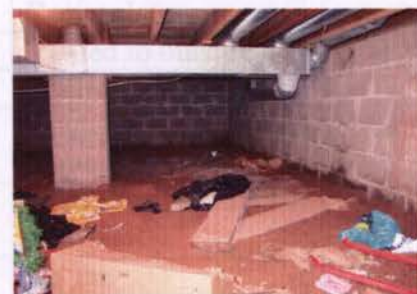
Damp clutter, including old clothes, cardboard boxes and garbage, was found in many crawl spaces (Figure 10). All but three inspected crawl spaces had interior access hatches which made it convenient for the occupants to use the crawl spaces for storage.

Figure 10 – Crawl space clutter

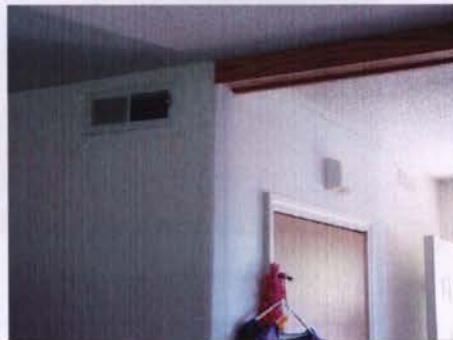
- **Heat Recovery Ventilators** Three homes were retrofitted with heat recovery ventilators. However, two systems were turned-off and one system had separate ductwork not tied to the furnace. The supply and return grilles to the house were inappropriately located in the living room and dining area, just around the corner from each other (Figure 11). The proximity of the two grilles short-circuits air supply around the home. The other two systems were tied into the furnace ductwork, providing fresh air throughout the home.

**Figure 11 – Supply and return registers for HRV units (both registers were sealed with tape for the blower door test)**

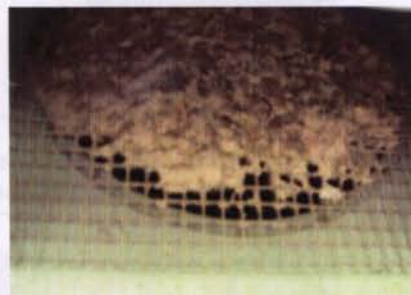
Two older homes that only received exterior inspections had HRV systems. Both fresh air intakes to the systems were clogged with debris (Figure 12), preventing fresh air from being pulled into the house.

**Figure 12 - Clogged HRV intake**

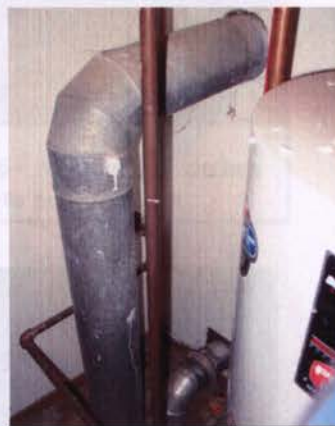
Two older, twenty plus years old, inspected homes had supply only ventilation systems. The systems consisted of a 6" diameter duct tied to the return side of the furnace (Figure 13). Whenever the air handler operated, fresh air was pulled into the home, mixed with the return air to the furnace and distributed throughout the home. Blocked air intakes were also found on these systems.

**Figure 13 – Fresh air intake from outside to return side of furnace**

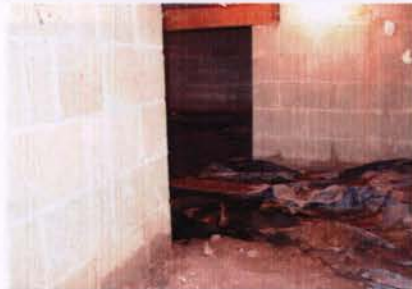
Eight of the inspected homes had plumbing leaks. A disconnected drain line had flooded the crawl space in home 3-4 (Figure 15). The MLRHA immediately took steps to correct this problem. All the remaining plumbing issues were minor leaks under kitchen sinks or water pressure tanks (Figure 16). A clogged bathroom drain was found in another home.

Figure 15 – Flooded crawl space due to disconnected drain line

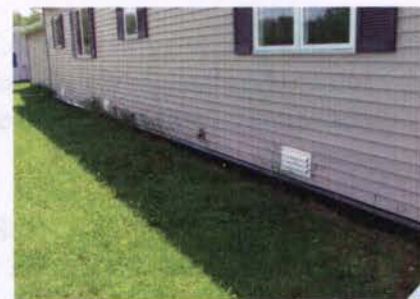
**Figure 24 – Typical vented crawl space**

Six crawl spaces were not vented; six were vented (Figure 24). The only break in the thermal boundary is the venting. The vents allow cold air to enter the crawl space in the winter causing wasted energy dollars, while increasing the potential for frozen pipes. This is analogous to opening a window in a heated room. Crawl space vents do not facilitate drying in the summer. If the crawl spaces are to be vented, then the floors above the

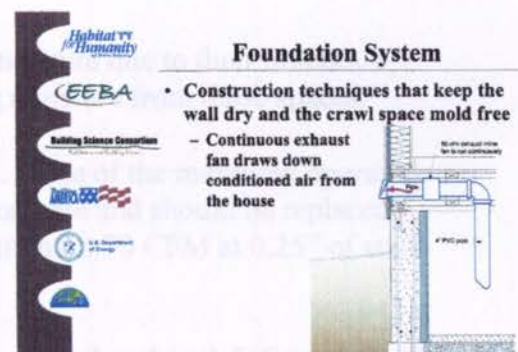
**Figure 25– Mechanical crawl space exhaust system**

- **Crawl Space under Negative Pressure** Seal all supply air registers and install exhaust fan in foundation wall (Figure 25). The fan should be rated for continuous operation and draw about 50 CFM from the crawl space. Conditioned air will naturally be drawn into the crawl space from the living space through joints and holes in the floor.

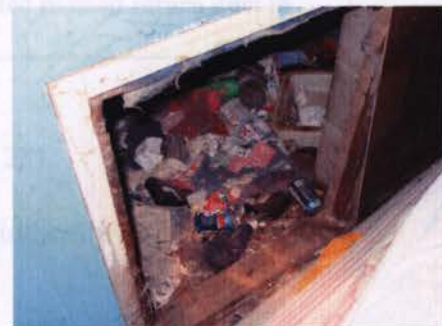
Figure 27– Garbage thrown in crawl space

- When fans are operable and vented to the outside, instruct occupants to use bathroom and kitchen exhaust fans during and after bathing and cooking activities to remove moisture from these spaces.
- Inform occupants not to use crawl spaces for storage or as a receptacle for garbage (Figure 27), unless they place storage boxes on slightly raised platforms or in plastic bins placed away from foundation walls.
- Discourage the use of rugs in half basements. If used, the occupants should inspect the underside of the rugs periodically for the presence of mold. Discard rugs with.

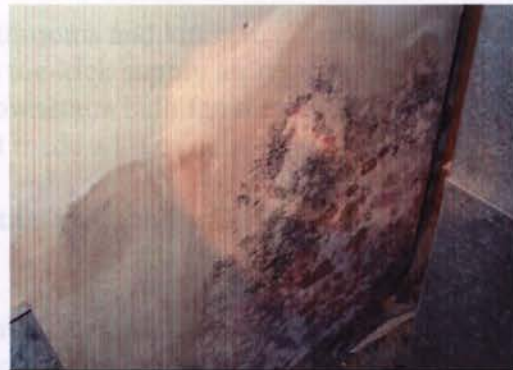
**Mold and Moisture Conditions:** The house had experienced flooding in the crawl space. Standing water was present in parts of the crawl space as was moldy debris (Figure 2). Mold was found on the drywall between the crawl space and house (Figure 3). Mold was also present in the utility room and spare room of the half basement (Figure 4). The furnace room was open to the crawl space and there was no door on the furnace room thus the crawl space was open to the entire house. The filter slot was open in the utility room (Figure 5). In addition, there was a hole in the living room floor to the crawl space. Mold was also found in the lower level bathroom.

Figure 3 – Mold on furnace room wall near crawl space

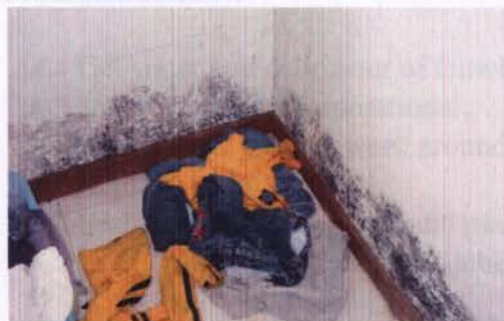
Figure 4 - Mold at base of spare room in half basement

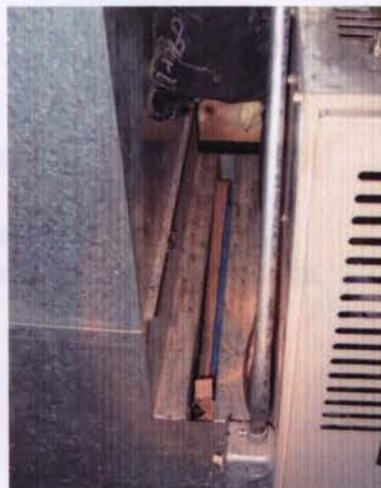
Figure 5- Open filter slot

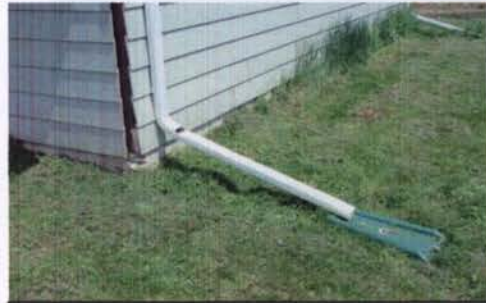
**Rainwater Management:** Gutters and downspouts with flip-up leaders were added in the fall of 2002 (Figure 6). The house was re-graded around the crawl space. Both measures were done to prevent water from draining into the crawl space. Site drainage was still quite flat on the side of the basement wall with two window wells.

Figure 6 - Flip-up leader

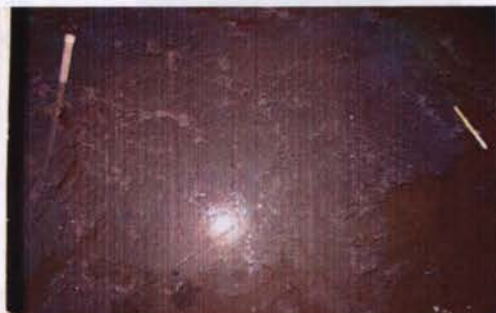
Figure 2 – Water in crawl space

- Remove water from crawl space and dry it out. Mechanical ventilation may be required to dry the crawl space.
- Install gutters and downspouts and direct water away from home.
- Re-grade around home where possible (will be difficult because house is sitting so low).
- Inspect for mold and rotted sheathing or floor joists, especially under the water heater.
- Seal all duct joints.
- Replace the broken window in the master bedroom.
- Inspect exterior corner of master bedroom where mold is present - check for holes in sheathing or the corner that may allow air infiltration.
- Replace bathroom fan and install kitchen exhaust fan that vents to the outside.
- Seal duct boots (the portions of the ducts that convert the round duct to a rectangular shape to fit the registers) to sub-floor.
- Seal crawl space vent and provide exhaust only ventilation in crawl space.

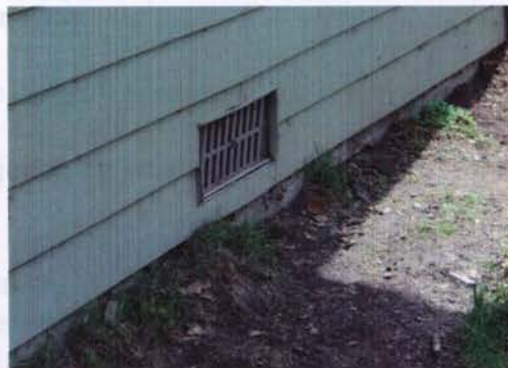
Figure 3 – Lone crawl space vent

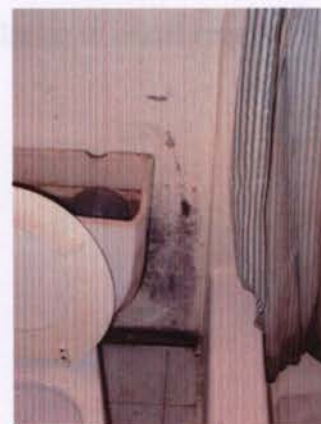
**Bathroom/Kitchen:** The kitchen fan was a recirculating one. The bathroom exhaust fan measured 0 CFM, although it made a lot of noise and was vented outside through a roof cap. Some mold was found on the wall between the toilet and bathtub (Figure 4). There a washing machine in the home, but no dryer. Clothes were hung to dry in the

Figure 4 – Mold on bathroom wall

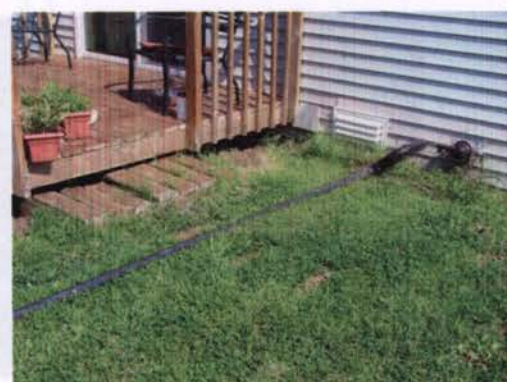
Figure 2 – Sump pump extender hose

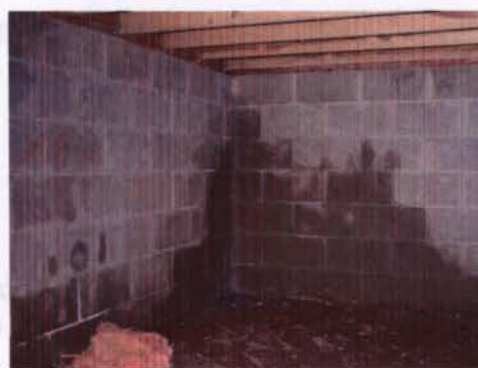
Figure 2 – Damp corner in crawl space

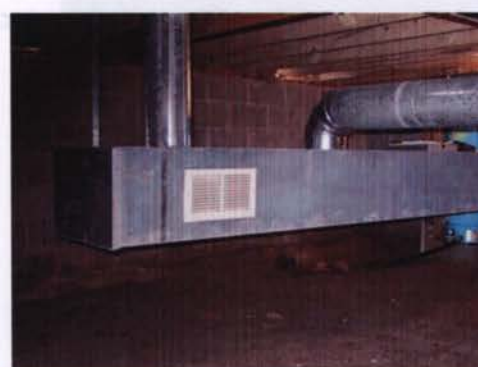
Mechanicals were present in the crawl space. An open supply and return grille were present in their respective trunk lines (Figure 3). Branch return lines were panned.

Figure 3 – Supply air register in crawl space

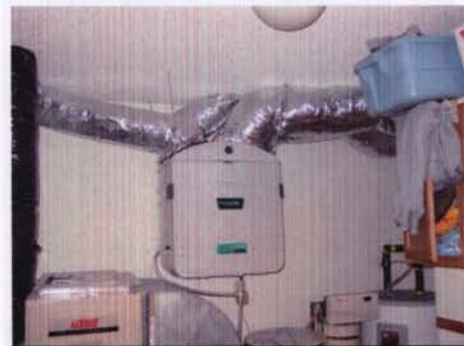
A heat recovery ventilation (HRV) unit was installed in the home but not connected to the furnace ductwork (Figure 5). The HRV was turned off when the home was inspected, yet appeared to have never been used previously. The HRV provided supply air to the living room. Return air was drawn from the dining area. Because of the proximity of the supply and return grilles, there was some short-circuiting of the air and fresh air was not reaching the bedrooms (Figure 6).

Figure 5 – HRV unit

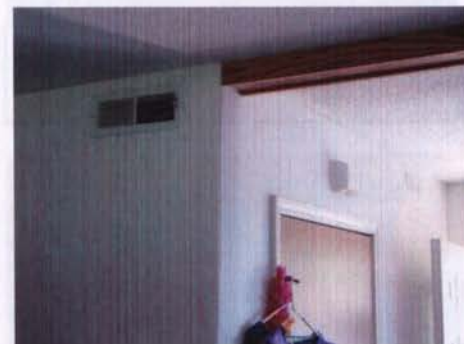
Figure 6 – Supply and return registers for HRV units (both registers were sealed with tape for the blower door test)

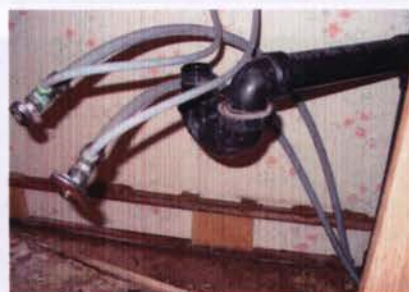
**Mold and Moisture Conditions:** No mold was found. Evidence of a previous roof leak was visible in the living room. In the main bathroom the drain was disconnected (Figure 2).

**Figure 2 – Disconnected drain beneath bathroom sink**

- Reconnect drain beneath bathroom sink.
- Replace bathroom and kitchen exhaust fans and vent to the outside.
- Inspect crawl space for signs of water damage.
- Install gutters and downspouts and drain water away from home.
- Repair or replace stained living room ceiling.

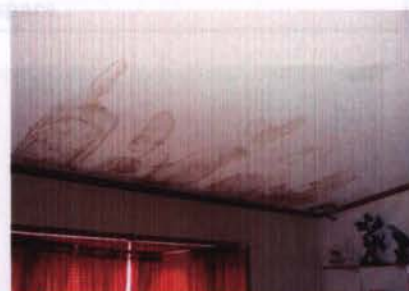
**Bathroom/Kitchen/Living Room:** The kitchen fan vented to the outside, but was non-operational. The main bathroom exhaust fan was non-operational. The master bedroom bathroom exhaust fan measured 23 CFM. The drain was disconnected beneath the main bathroom sink. Water stains were visible on the living room ceiling from a previous roof leak that has been repaired (Figure 3).

**Figure 3 – Water stains on living room ceiling**

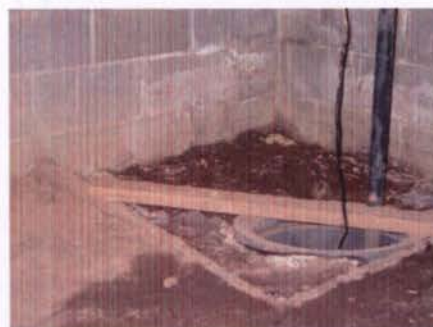
**Mold and Moisture Conditions:** No mold was found in the home. The crawl space floor and foundation wall adjacent to the garage were damp.

Figure 2 – Wet sand near crawl space

- Check sump pump for proper operation.
- Replace missing downspouts.
- Re-grade around home, especially on the garage side.
- Close supply air register to crawl space.
- Seal crawl space vents.
- Provide exhaust only fan in crawl space.

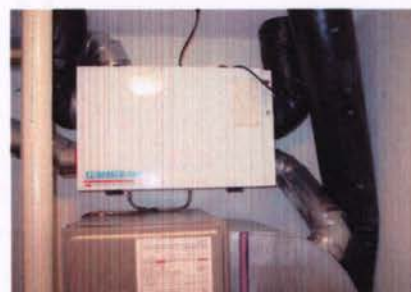
**Heating System:** The furnace was propane fired and 80% efficient. The water heater was electric. A heat recovery ventilator (HRV) was also present and was controlled by a humidistat (Figure 3). The HRV was "on" and set at 35% RH. The HRV had a main

Figure 3 – HRV installed over furnace

supply vent to the living room and a main return from the dining area. However, branch lines connected the HRV to the furnace so that fresh air was provided to the other living spaces in the home.

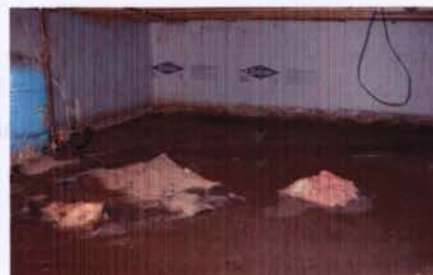
**Mold and Moisture Conditions:** The crawl space floor was wet (Figure 2). The debris present in the crawl space was moldy. Mold was also found on the floor sheathing beneath the bathtub (Figure 3).

**Crawl Space:** The concrete floor of the crawl space was wet. Debris was moldy. The water line from the flooding was visible on the wall. Floor sheathing under the bathtub was moldy. Supply ducts are located in the crawl space – a supply register could not be found. The crawl space measurements were:

**Figure 2 – Water in crawl space with debris**

- Dry-out crawl space and remove debris.
- Install exhaust only fan in crawl space.
- Install kitchen exhaust fan vented to outside.
- Replace bathroom exhaust fan and vent to outside.
- Clean mold from or replace the floor sheathing underneath the bathtub.
- Install supply register in the crawl space.

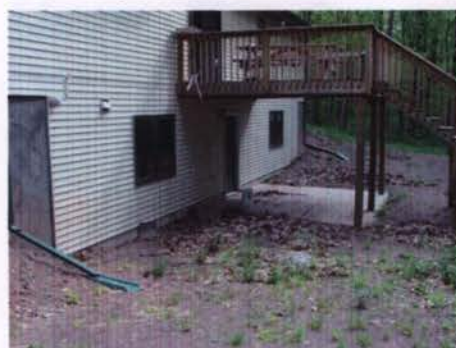
The home had a walk-out basement in the back where site drainage looked poor. It appeared that water draining from the sides of the home could collect at this point (Figure 2).

Figure 2 – Site drainage at rear of house poor

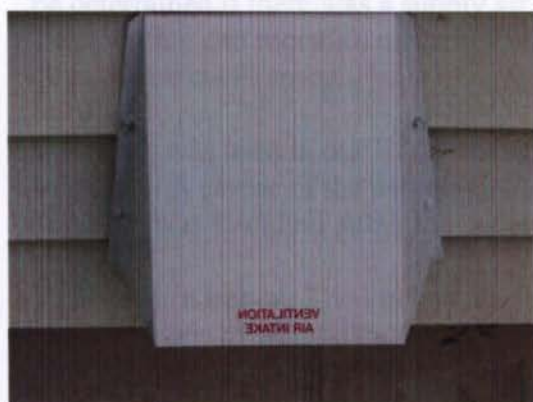
The fresh air intake to the HRV was clogged (Figures 3 and 4).

Figure 3 – Fresh air intake

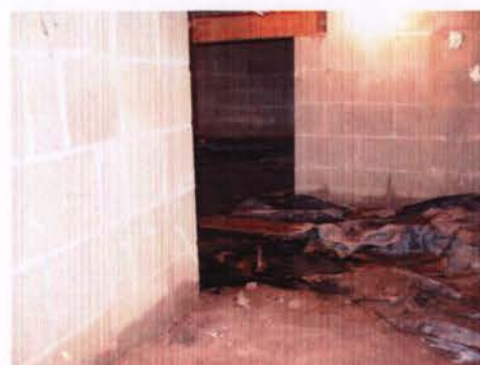
Figure 2 – Water in crawl space

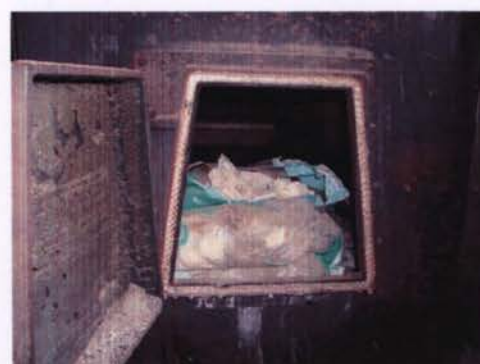
**Heating System:** The furnace was combination wood/propane fired. It was apparent, however, that garbage was being burned in the unit (Figure 3). A central return was used for the furnace. The water heater was natural draft propane.

Figure 3 – Garbage in wood furnace

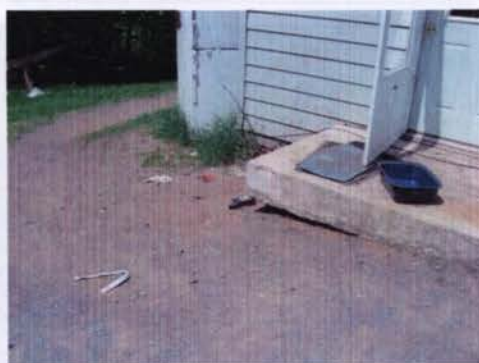
Figure 2 - Erosion along pad for side door

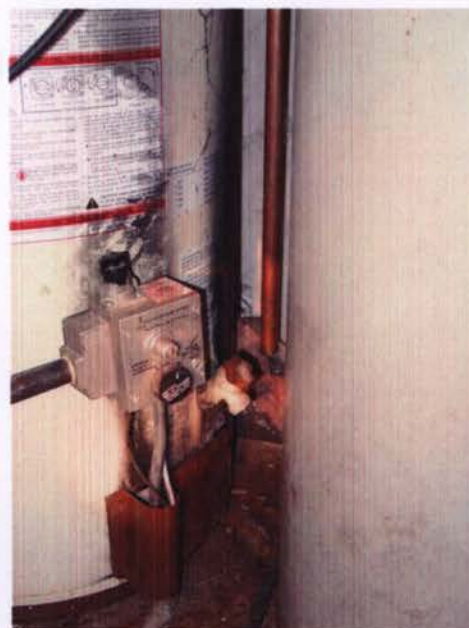
**Heating System:** The furnace was fired with propane and was 80% efficient. There was no filter in the filter slot. The water heater was propane fired and there were signs of flame roll-out (Figure 3). A washer and dryer were present in the home. The dryer had a 90° angle to the outside vent that severely restricted air

Figure 3 - Signs of flame roll-out on water heater

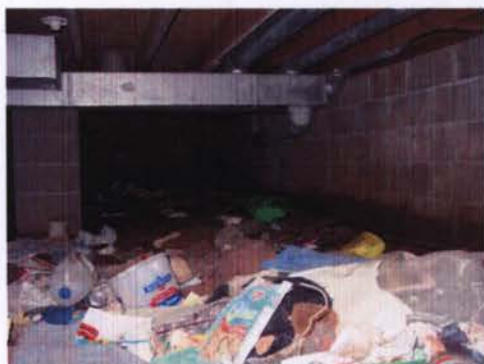
**Mold and Moisture Conditions:** The crawl space was wet and filled with clutter. Mold was found in both bathrooms and lower level bedrooms. Water damage was found under the kitchen sink.

Figure 3 – Wet crawl space with debris

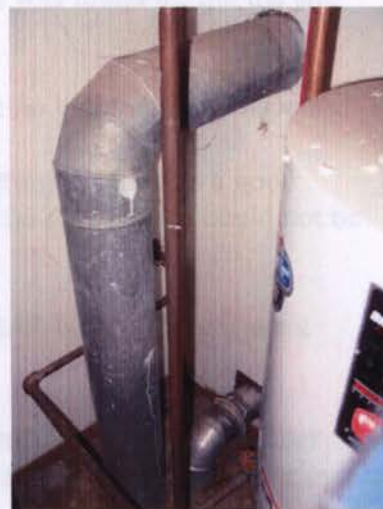
**Heating System:** The furnace was a combination propane/wood unit. The water heater was propane fired. There is a 6" diameter duct from the outside to the return side of the furnace (Figure 6). However, the fresh air intake was clogged (Figure 7). The water heater vent was rusted indicating a flue condensation problem (Figure 8).

Figure 6 – Fresh air intake

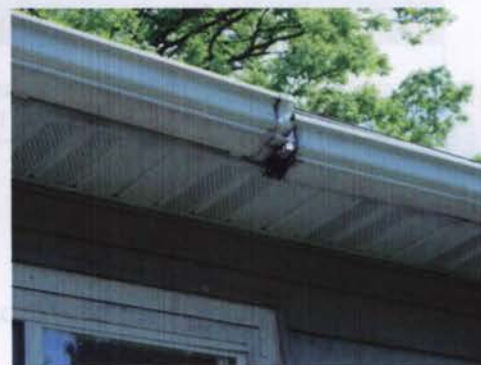
Figure 3 – Disconnected gutter

**Rainwater Management:** Site drainage was flat. Leaders were not present on the downspouts (Figure 2). Some gutters were blocked with debris. One gutter was disconnected (Figure 3).
